**Home Inspections Of Michigan**

## Confidential Inspection Report

**10/05/2015**

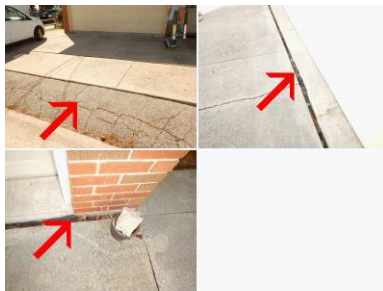
Driveway:

Driveway Type: Concrete, Asphalt, Cracks noted are typical, Cracks noted are major, Surface raised/settled.

### Movement Noted

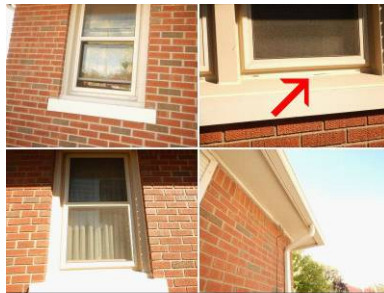
*Flashing & Trim:*

Metal materials.

**Some Caulking may be needed**

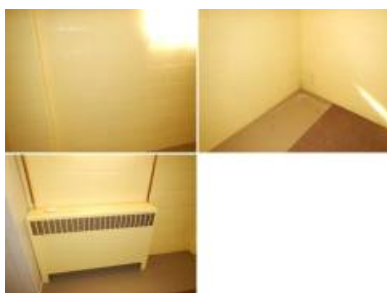
*Walls:*

Walls are concrete block. Exposed portions of the interior foundation perimeter walls appear to be satisfactory.. Walls may need some cleaning.

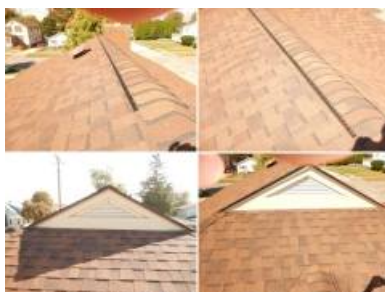
Roof Covering Condition:

Appears serviceable, TYPICAL MAINTENANCE RECOMMENDED. This usually consists of repair/replacement of damaged/missing shingles. This maintenance should help insure the weather tightness of the building and should be performed on a regular basis.

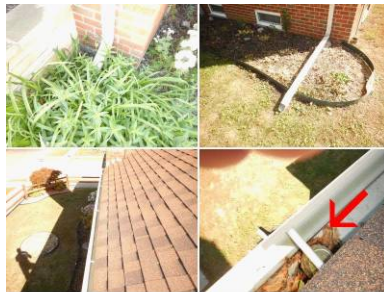
**Gutters & Downspouts:**

Gutters and downspout materials are aluminum. Building is fully guttered, Debris in gutter, Extend downspouts to route rainwater away from the building.

**Some Debris in gutter**

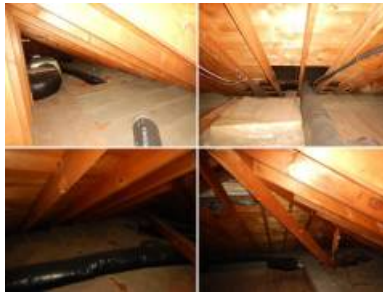
Depth & R-factor:

Blown in cellulose. Insulation is installed between floor joists. Recommend additional insulation in the attic area.

8-9 inches, R-32.

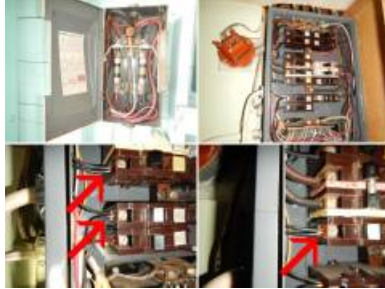
Main Panel Observations:

Circuit and wire sizing correct so far as visible, Grounding system is present Older panel , double taps noted in panel down stairs.

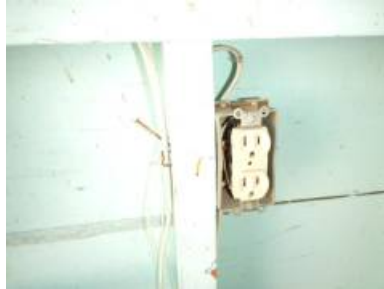
110 volt electrical outlet is not grounded (Danger) exterior walls center wall was grounded.

Ground Fault Circuit Interrupter (GFCI) outlets are recommended for installation at exterior, garage, bath rooms & kitchen outlets. Missing cover plates.

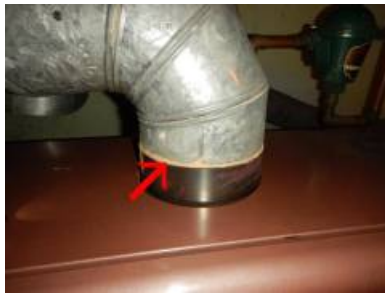
Flues, Vents, Plenum:

The flue pipe is metal During this inspection it is impossible to determine the condition of the interior of the flue. The interior of the flue may be deteriorated, but during a visual inspection we were unable to see the interior walls. Small issue with vent from boiler, the pipe is reversed and should be over top of the lowest pipe to properly vent.

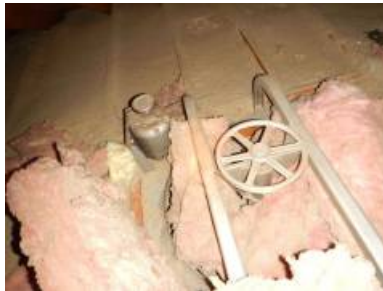
Whole House Attic Fan:

Fan is not operational.

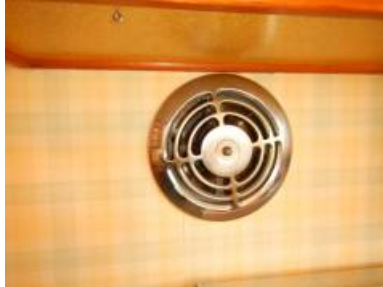
### Ventilation:

Exhaust fan is noisy. May need repairing or replacing.

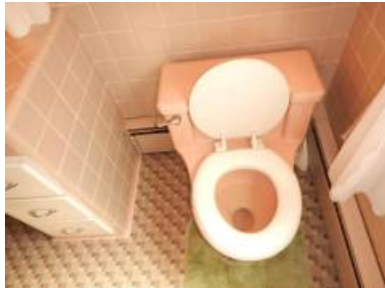
*Main Bath:*

Appeared Serviceable Slow flush.

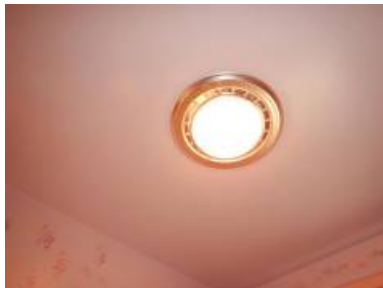
*Main Bath:*

Exhaust fan makes unusual noises. May need replacing.
